# Crack Detection for Aerospace Quality Spur Gears

Harry J. Decker U.S. Army Research Laboratory, Glenn Research Center, Cleveland, Ohio

Prepared for the International 58th Annual Forum and Technology Display sponsored by the American Helicopter Society Montreal, Quebec, Canada, June 11–13, 2002

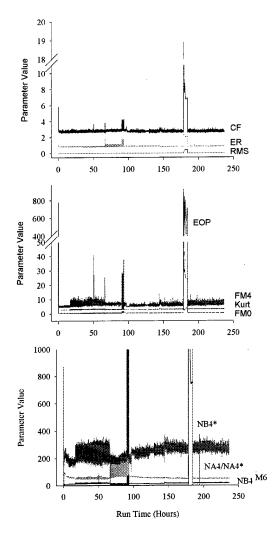
Figure 6. Test 1, case accelerometer parameters

Figure 6 also shows the results of when the facility accelerometer lost power and shut the facility down (approximately 70 hours), and an unexplained set of conditions at about 170 hours. Experience has shown that several of the diagnostic parameters take a significant amount of time to settle back into steady state like conditions after an interruption, if at all. It is important to note the amplitude of these disturbances for comparison later on. It is proposed that during a shutdown, the temperature decrease changes the system dynamics by altering the clearances and contact stresses from the previous conditions. In this figure there is no obvious indication of crack initiation, progression or separation of the gear tooth.

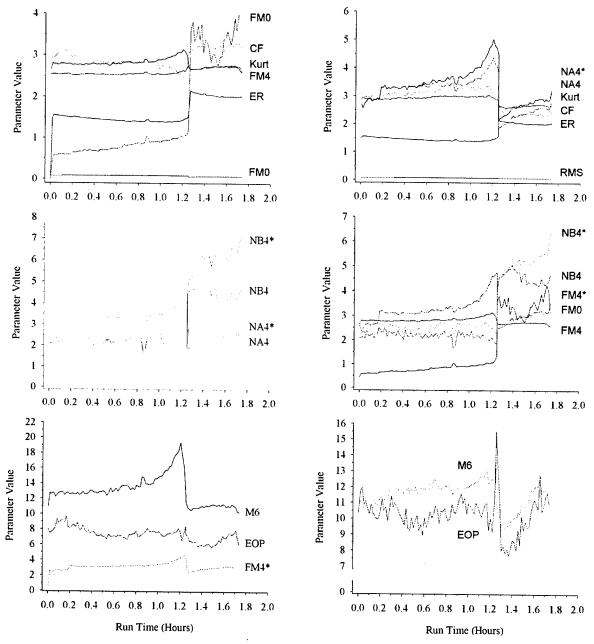
Figure 8. Test 2, case accelerometer parameters

Figures 8 and 9 present the results of applying these parameters to the vibration recorded by the two accelerometers. In this test, almost all of the techniques examined indicate something at 1.25 hours. The variations due to the shutdown and subsequent startup are readily visible.

The ideal parameter would show a step change at initiation of damage, a linear increase during damage progression with another step increase to a high level to indicate the loss of the tooth for the remainder of the run. The M6 parameter demonstrates one of the deficiencies of several of the parameters. Some of the parameters after increasing to indicate damage, reduce in value as the damage becomes more distributed. If the peak is not detected, there is a very real possibility of encountering a Type I error. The results of the NB4\* parameter, at least in this test, demonstrates the desired characteristics of a robust parameter.

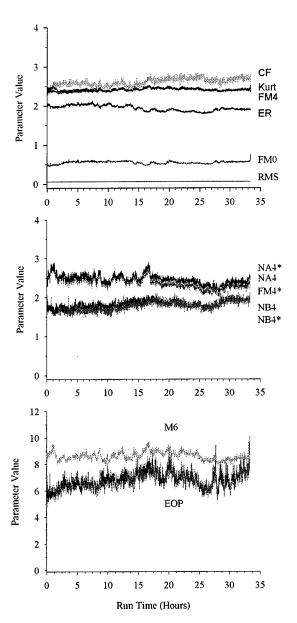
Figure 11. Test 3, case accelerometer parameters

As seen in Figure 11 and Figure 12, the widely used parameters do not readily indicate any crack initiation or propagation. The last 3 points of FM0 in Figure 11 and NA4 and FM0 in Figure 12, with their abrupt increase in value, may hint at the damage. In this case, the shaft mounted accelerometer, with its shorter and more direct transfer path indicates the damage better
